# Manhole Inspection Summary

Manhole # S11GG\_037MH

Insp Date: 1/21/09 9:12 AM

**Location** Address: **3121 PRESBURY ST**

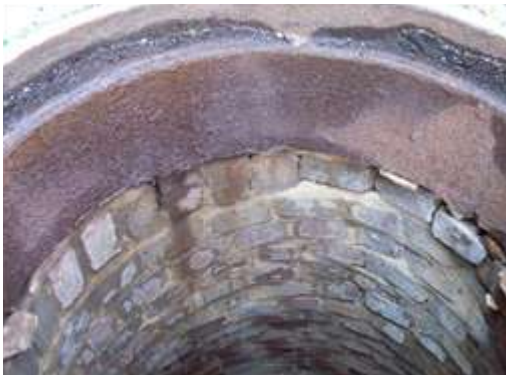
Defect 3

Condition: ☐ Sound ☒ **Cracked** ☐ Root Intrusion ☐ Loose Brick ☐ Deteriorated

CRACKED CORBEL

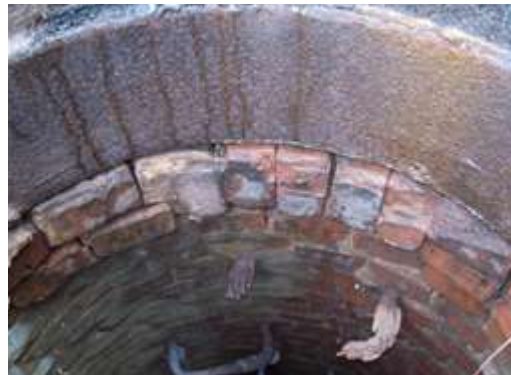
Defect 2

Condition: ☐ Sound ☐ Cracked ☐ Root Intrusion ☒ **Loose Brick** ☐ Deteriorated

**Steps** Count: **2** Missing: **1** ☒ **Corroded**

CHIMNEY LOOSE BRICKS,  
CORRODED STEPS AND MISSING 1

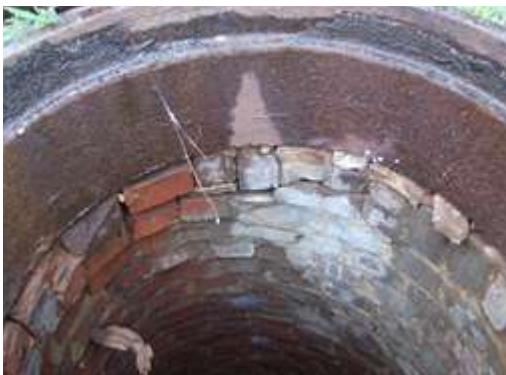
Defect 1

Infiltration: ☐ None ☒ **Joint** ☐ Cracks ☐ Mortar ☐ Roots ☒ **Wall**

INFILTRATION AT CHIMNEY JOINT  
AND WALL

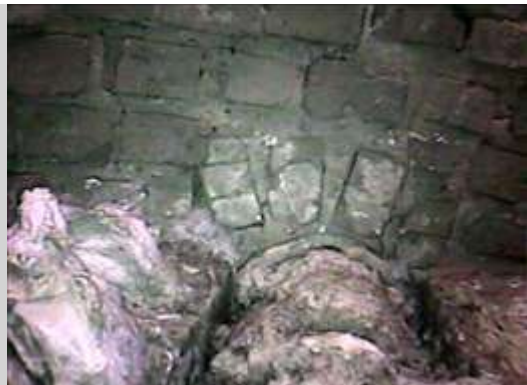
3 O'Clock Inflow

PIPE IS COMPLETELY CLOGGED UP WITH  
SLUDGE AND DEBRIS.

Deposits: ☐ None ☐ Mud ☒ Sludge ☒ Debris ☐ Grease

Silt Depth: **8** (in.) Deposits Extent: **Heavy**
